THE QUARTERMASTER SERVICE PROJECT

QUARTERMASTER

QUARTERMASTER SERVICE PROJECT
YOUTH ACTIVITIES BUILDING RENOVATIONS

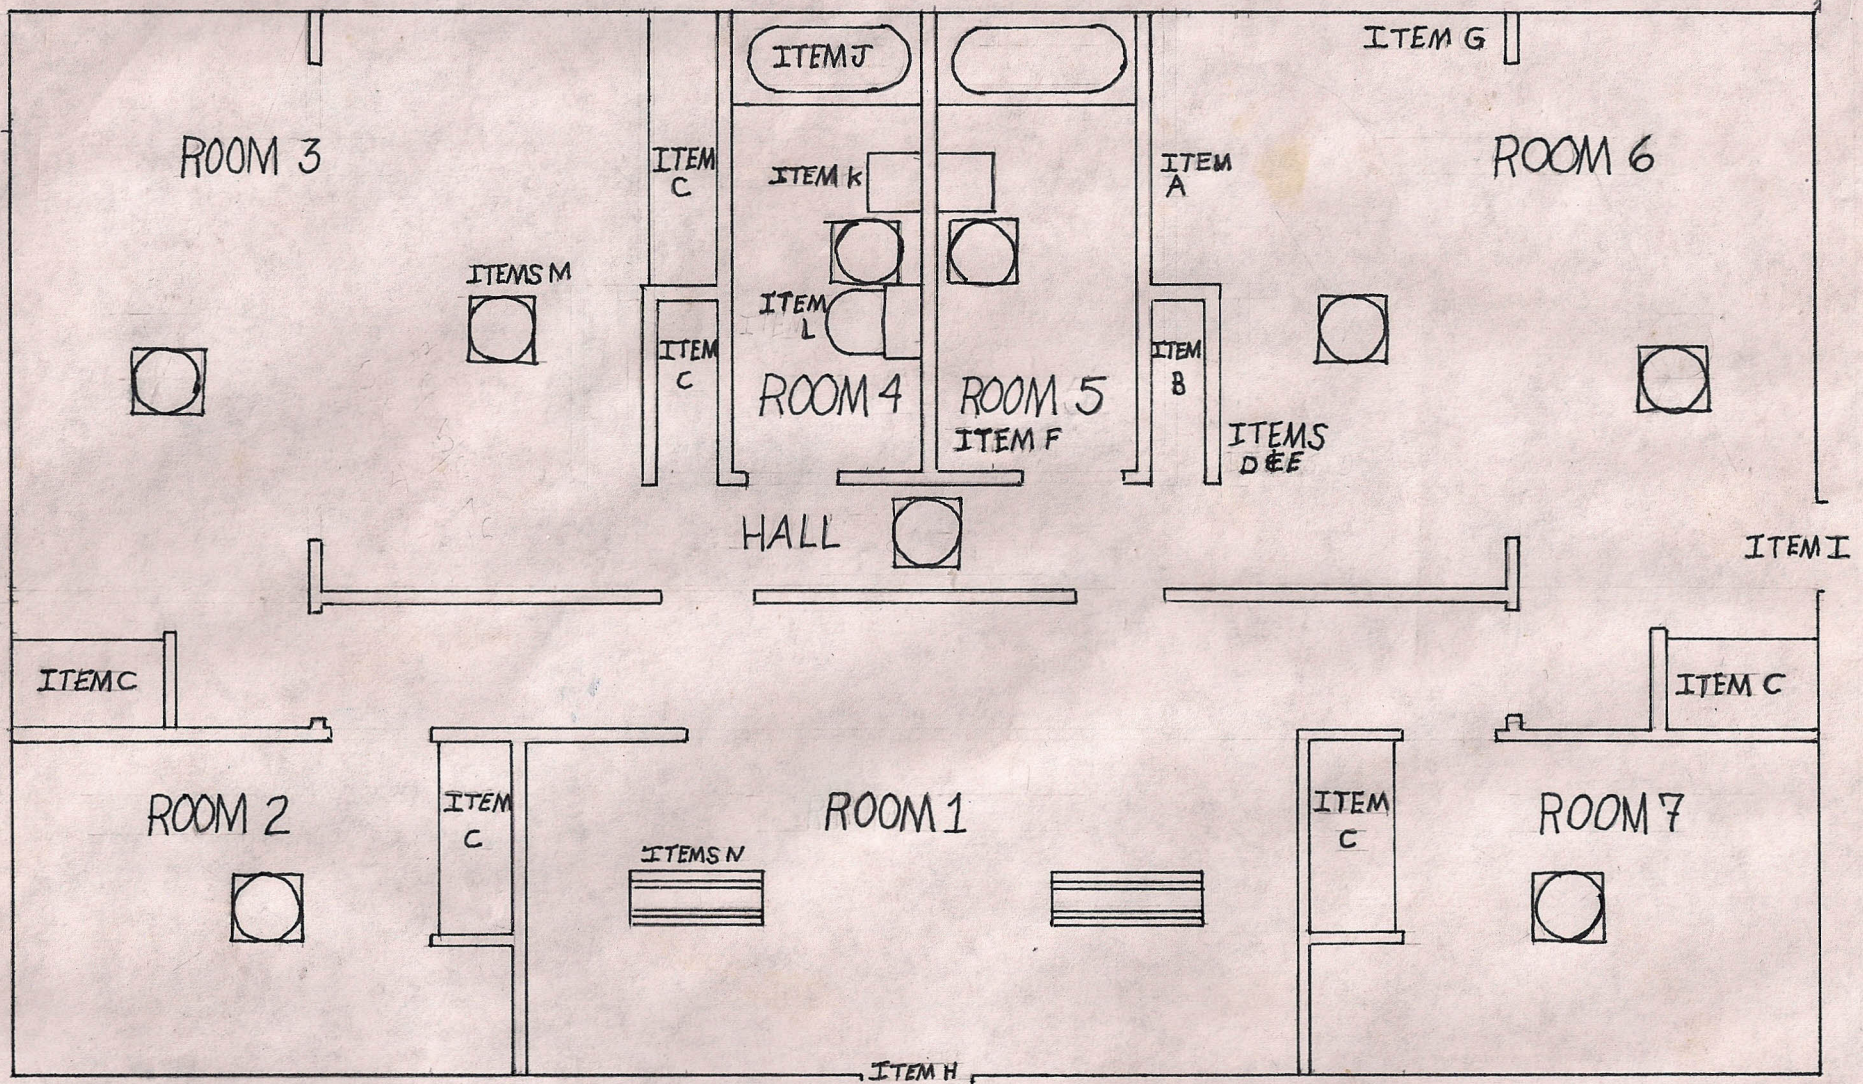
The building currently has five rooms, two bathrooms, and two closets. One of the bathrooms, room 5,* does not have a toilet and is being used as a storage room. Both have a tile floor, a bathtub, and a sink.

The next room, room 6, was redecorated by a church youth group by spattering oil based paints around the room. The result was an uneven, multi-colored surface that is not very pretty. In several spaces throughout the building, the plaster is cracking or peeling quite bad. One spot in particular shows where the sheetrock is separating from the rafters.

The illumination in a majority of the building is provided by two-bulb light fixtures. Only one room currently has fluorescent lighting. The floor is a hardwood floor. At one time, a carpet was glued down to it. Now the carpet has been removed and the foam backing was scraped up, leaving a dark uneven residue. The walls have been painted various colors ranging from a bright white in room 1 to baby blue-plus in room 6.

After consulting a few people, a list of equipment and consumable materials was drawn up based on the work to be done. This list can be found on pages 4 and 5. The first thing to be done will be the removal of the wall and closet between rooms 5 and 6 (items A and B). An air duct and electrical box is in one portion of this wall (item D and E). The air duct will be cut down and turned into a floor vent. The electrical box, which contains a light switch and an electrical outlet will be re-routed to where the current bathroom switch is (item F). Once the wall is completely removed, the remaining bathroom fixtures will be removed, properly capped, and a tile splash guard removed. The tile floor will be pulled up next and replaced with plywood the same thickness as the floorboards. The access holes will be patched properly by cutting a square of sheet rock nailed to the wall and plastered for a uniform surface.

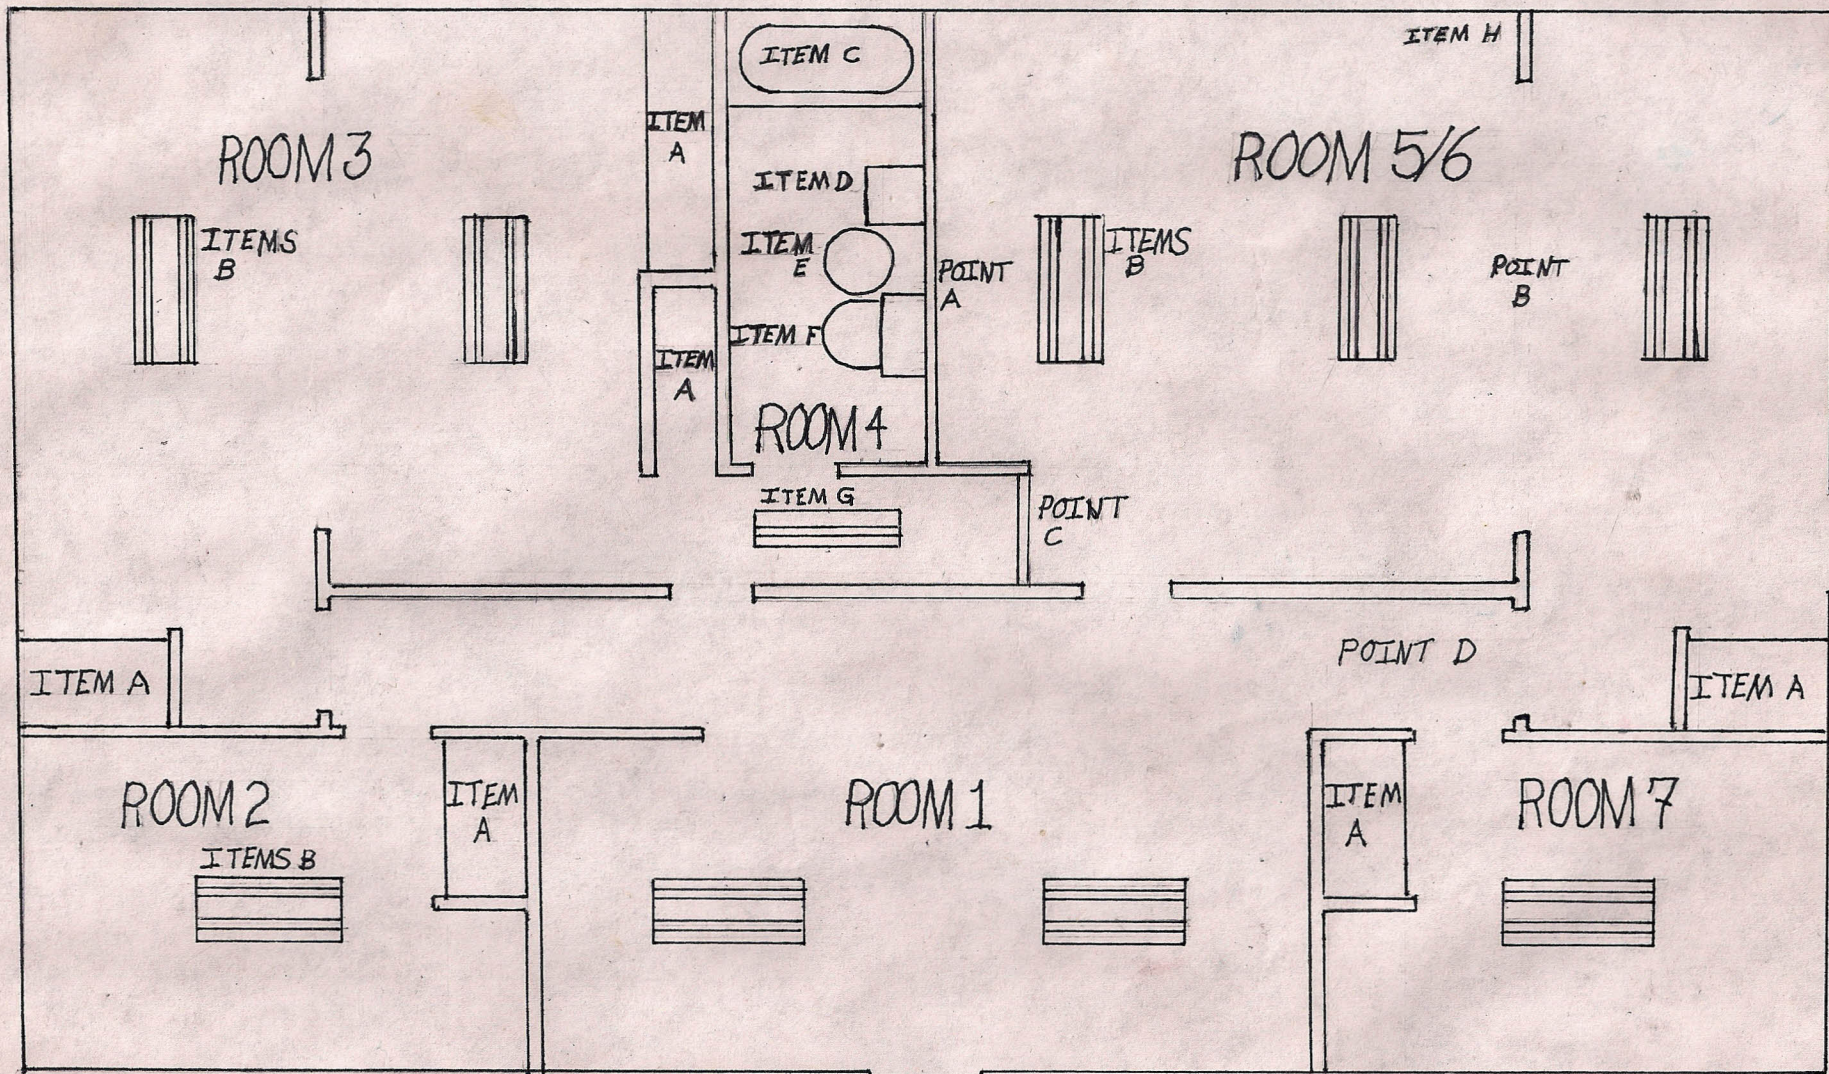
The ceiling and walls of room 1 have some cracking and room 5/6 has drooping. The drooping problem exists at point B**. On the surface, it appears to be the weight of the plaster causing the sheetrock to pull away from the rafters. Since the plan calls for the complete removal of wall A and

closet B,* it probably would be best to re-do the ceiling to provide uniformity while taking care of the drooping at the same time. The existing ceiling would be pulled down between points A and B**. Before work is continued, a survey will be conducted to check for water damage or any other forms of deterioration in the structure. Once the debris is clear, the new sheetrock will be nailed into place. Taping the seams and covering the nail heads will soon follow. It will be plastered with a texture created by lightly touching the ceiling with a trowel. This will create enough texture to assist in hiding any mistakes and the signs of amateur workmanship. A 2x4 will be nailed and plastered over the seam of the old a new ceiling at point C** to mark the transition. At point D in room 1, an entire ceiling panel shows signs of past water damage; though no indication of recent damage is present. Both the plaster and sheetrock is cracked and will have to be removed. It will be cut at the most convenient spot and a new panel of sheet-rock will be tacked into position and plastered in the same manner except for it being a smooth surface. Meanwhile, every place where there is signs of peeling or chipping plaster will be patched to prepare for painting. At the same time room 5/6** will be scraped down to a level surface.

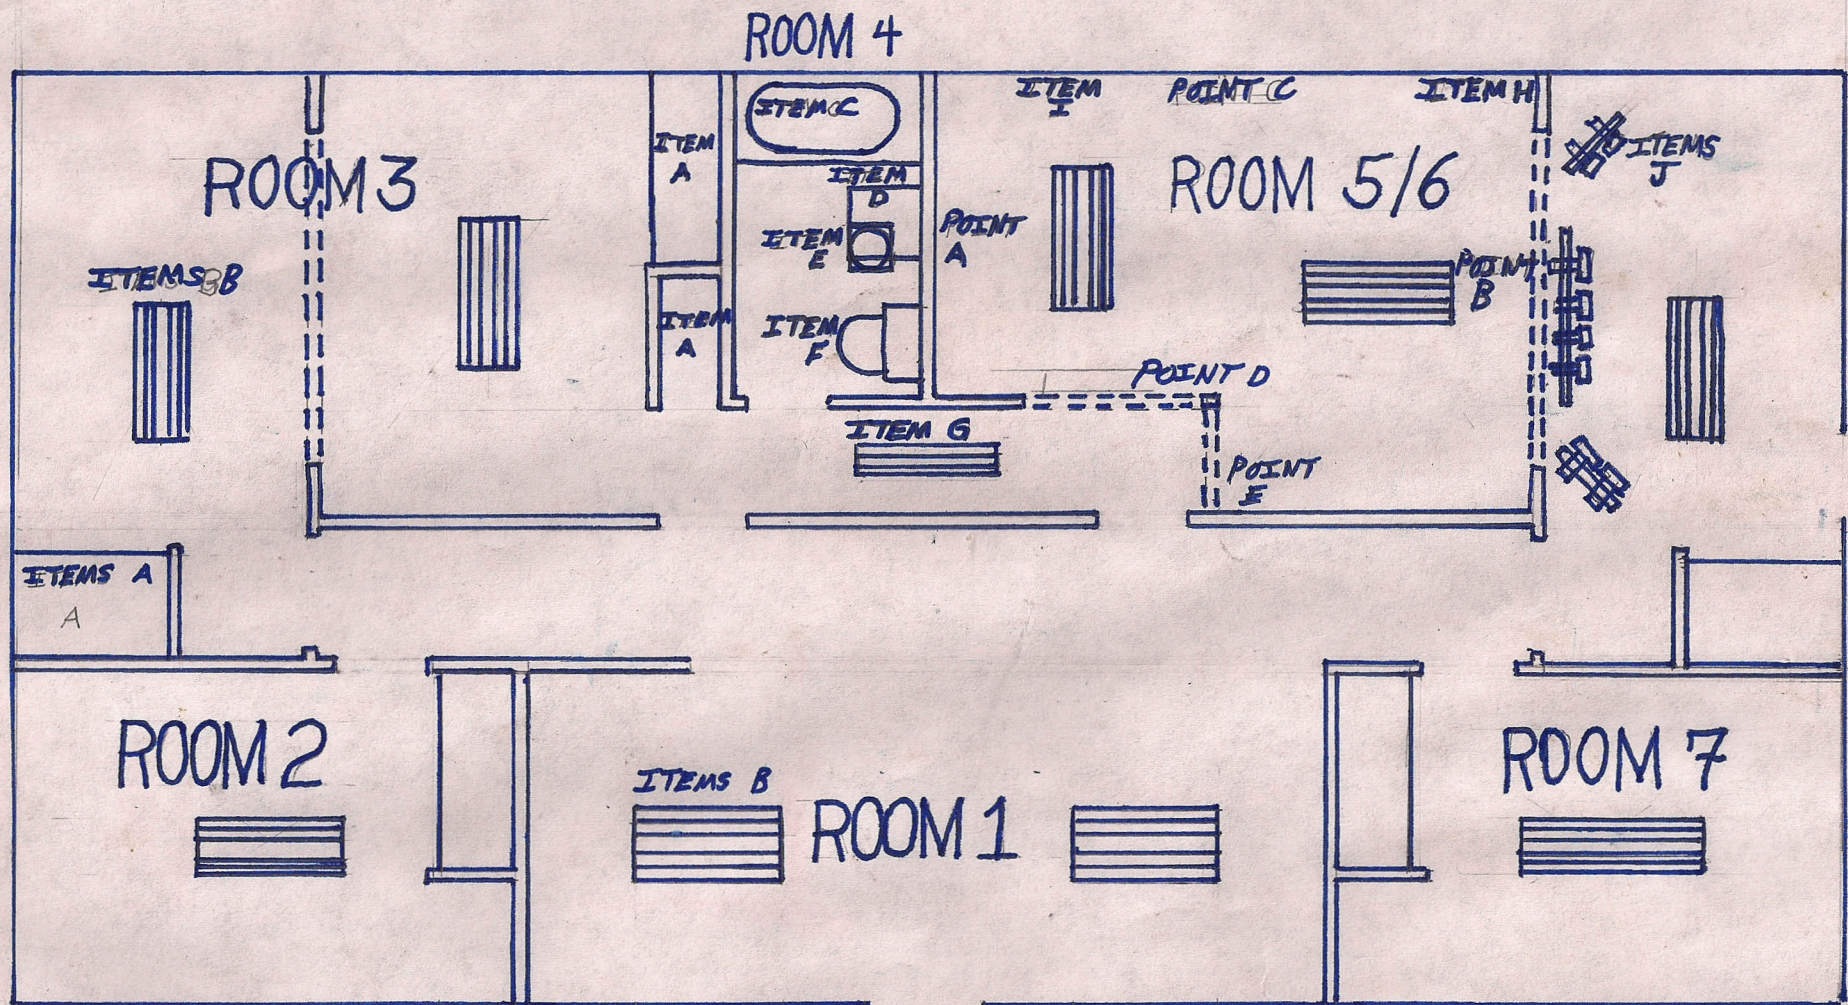
In a couple cases, the old and new walls and ceiling did not match up(*). A 1x4" was used to fill in where a door jam had been at point E. Another 1x4" near point C and a 2x4" between points D and E were used to ease the transitions at their respective places. In another case, a crown molding had to be placed around the top of one portion of the ceiling due to the lack of rafters at the edges.

The first change was to add track lighting on the ceiling near point B (*). This would allow the room to be used as an auditorium by the Scouts and Royal Ambassadors. The wiring was arranged so a light technician could operate all of the lights between points A and B and the track lights from the rear of the room.

The track lights are arranged on three circuits: One four-foot track and two, two-foot tracks. This allows independent control over each of the tracks. A new electrical outlet has been placed near point C to facilitate the possible use of a projector or travel spot. The tracks themselves are arranged with the four-foot track in the center and six-inches away from the archway at point B, flanked by the two two-foot tracks at 45 degree angles. No more than one light per foot of track is being allowed on any one track.

The second and perhaps most important change is due to the discovery of a support wall at point D. Originally, the plan called for the complete removal of the wall up to the doorway of room 5*. But with this discovery, the plans needed to be altered slightly. Two 2x4" studs were nailed together and positioned to support the rafters where the wall had been at one time. For uniformity, a 2x4" was nailed into place eight inches down from the ceiling, in keeping with the archway at point B, and covered with sheet rock.
